VLCC with Hempaguard X7 sees no hull biofouling after 5-month idle period

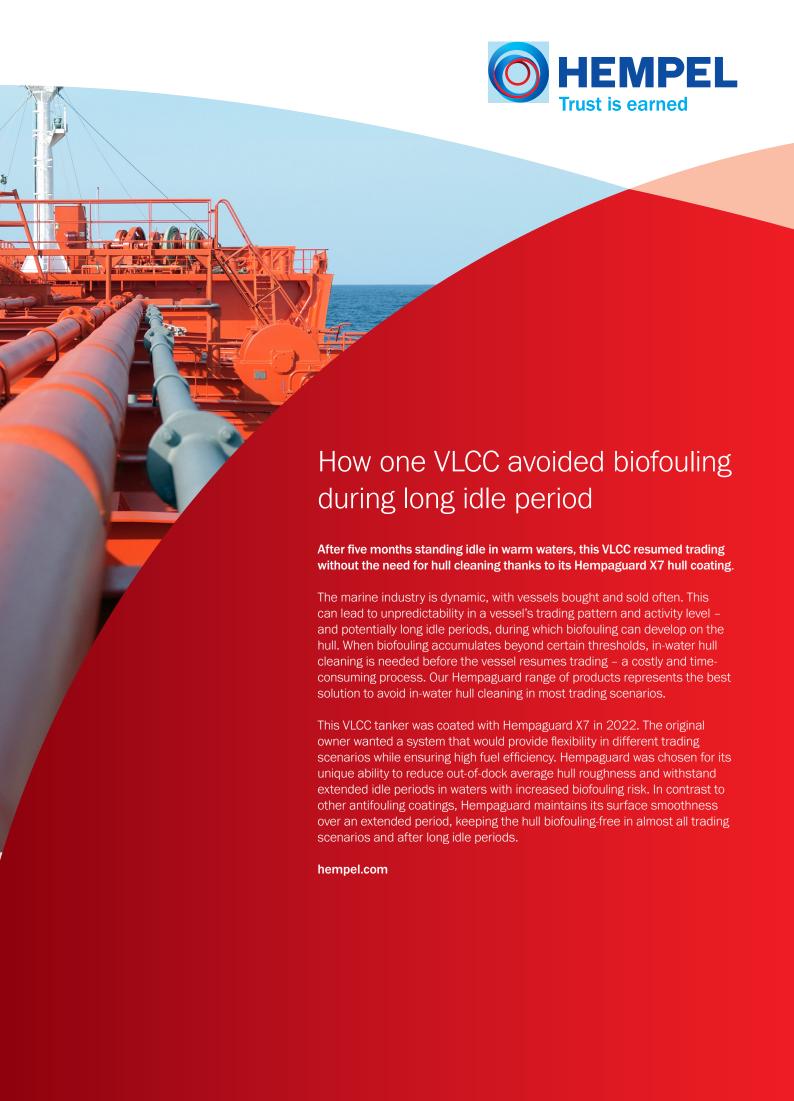
With any other antifouling coating system, a long idle period like this would lead to extensive biofouling growth on the hull, which would require expensive redocking or a challenging hull cleaning process. However, an in-water inspection revealed that the hull was in excellent condition. No in-water cleaning of the flat bottom or vertical sides was necessary – saving time and money for both the vessel seller and buyer.

Photos from the in-water hull inspection showed that verticals and flat bottom were clean
