Troubleshooting in floorcoatings

Cause, repair
and prevention

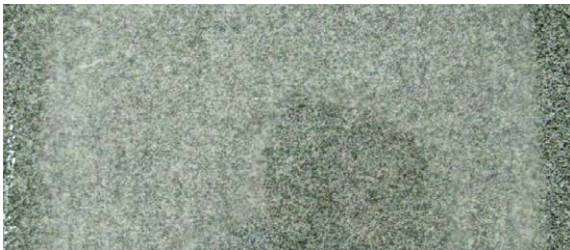
Milky/cloudy coating

There is a milky or cloudy appearance in wet or cured coating material.

Moisture: Moisture in the concrete or high humidity levels can cause moisture to be present on the surface when the material is applied, or before it is fully cured. This can result in a milky appearance or greasy film. This condition is sometimes referred to as “blush” and is more prevalent with certain epoxies.

Thick application: A milky or cloudy appearance may result from the coating being applied too thick. In this case, the milky appearance will be more noticeable if the coating is clear.

1. Remove affected material by sanding with #60 grit sandpaper.
2. Apply additional coats when humidity is at acceptable levels.
3. If a “greasy” film appears, solvent wipe with Xylene.

1. Remove affected material by sanding with #60 grit sandpaper.
2. If a greasy film appears, solvent wipe with Xylene.

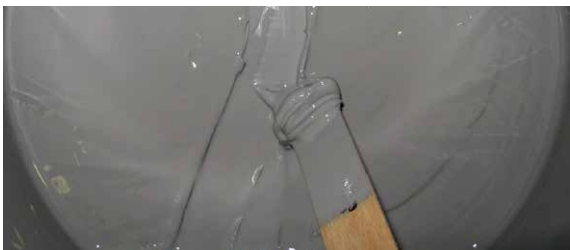
Product settling

Solid material settles in the bottom of the bucket. This typically occurs in the pigmented/colour side of a product.

Time: Some products have a tendency to settle over time.

- If there are signs of pigment settling, special care needs to be taken during initial mixing.
- Make sure mixing paddle reaches bottom of bucket and mix the settled material well to ensure pigments are dispersed back into product.
- Always pre-mix pigmented side before adding hardener.
- If settlement is pasty or dry and does not mix back into material, do not use.

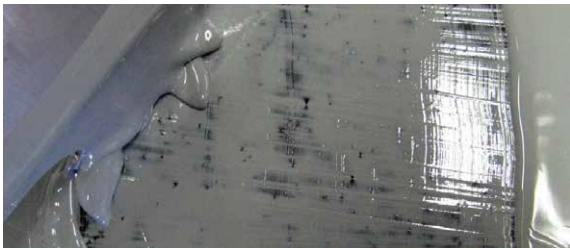
Slow cure/ not curing

The material does not fully cure or is still soft after 24 hours.

- **Improper mix ratio**
- **Improper mixing**
- **Cold materials**
- **Cold ambient temperatures**
- **Cold surface temperatures**

1. Fully remove the uncured coating down to the clean substrate by solvent wiping, scraping, grinding or shot-blasting.
2. Recoat per the instructions in the product data sheet or method statement.

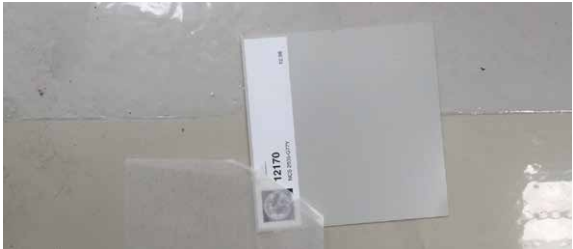
Yellowing

Topcoat has developed a yellow hue. This problem will affect epoxies regardless if the epoxy is clear or not.

- Epoxy has been exposed to partial or direct sunlight.

1. Remove any dirt, grease, oil or any other contaminants by pressure washing. Heavy oil or grease will need to be removed first by using an industrial-type degreaser.
2. Once floor is dry, sand entire area using #60 grit sandpaper with a circular floor sanding machine.
3. Clean floor to remove dust/debris from sanding.

4. Apply 1 or 2 coats of PU topcoat.

4. Re-apply one broadcast application.
5. Apply both seal coats using 100% solids pigmented epoxy.
6. Apply one final coat of PU topcoat.

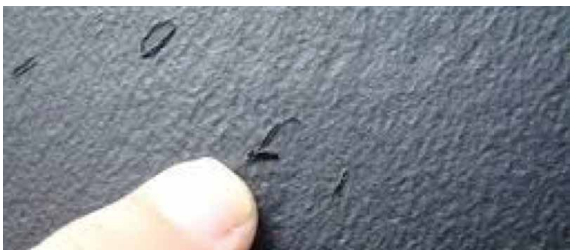
Irregular particles

Usually small, irregular particles in the paint film caused by foreign matter – e.g. dust, dirt, fibres from the roller. Can occur in different sizes, shapes, types and patterns.

- Poor cleaning of the substrate prior to application of the coating.
- Loose fibres from the roller.
- Contamination from the air.

- For severe faults, sand out the problem and repaint.

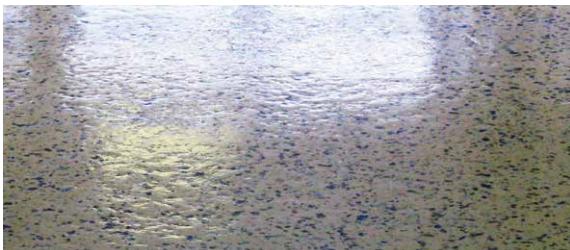
Orange peel is a stipple finish appearance in the final topcoat of epoxy or urethane flooring system. Some flooring manufacturers offer this finish as part of their systems; however, it is not always desirable to the customer.

Cold substrate/materials: If the substrate temperature is below 10°C, the epoxy or urethane will not flow and level out, and can produce the orange peel finish. This will be more prevalent if the topcoat is applied in a thin layer, somewhere between 75-150 micron film thickness, wet. The combination of a cold substrate and cold materials can readily produce this type of finish.

Hot substrate/materials: Hot temperatures can also result in an orange peel finish. If the substrate is above 35°C, the topcoat may cure too quickly. This rapid curing will cause the material not to flow and level out. Just as in cold temperatures, thin topcoat layers, hot substrate temperatures and hot material can produce an orange peel finish.

1. To remove the orange peel finish, the floor will need to be sanded with a circular floor sander using 60-80 grit sandpaper. Sand the floor to a smooth finish.
2. Vacuum thoroughly to remove dirt/debris and solvent wipe with Xylene.
3. Apply topcoat material.

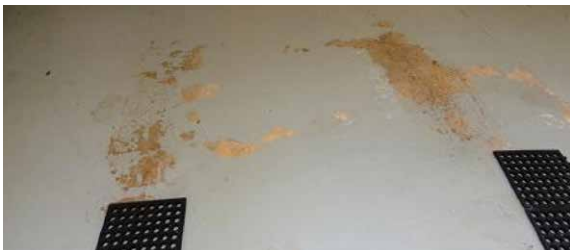
Peeling in parking areas

Flooring system is delaminating and peeling in areas where tyres are consistently in contact with the coating.

Thin system application: A floor coating system applied at insufficient coverage rates may delaminate.

Project specification: The applied system was not designed for project conditions.

Poor surface preparation: Substrate was not properly prepared for acceptance of coating system.

Improper cure time: Coating was not fully cured.

1. Remove all loose, peeling, or unbonded material.
2. Remove oil or grease by using an industrial-type degreaser. Deeply penetrated contaminants may require removal by mechanical methods.
3. Abrade concrete to a CSP2 or CSP3 surface profile.
4. Ensure substrate is clean and dry prior to coating.
5. Re-apply coating as per the product data sheet or method statement.
