## Hempel's Condition Survey enables full coating repair without plant shutdown

## Hempel's Condition Survey

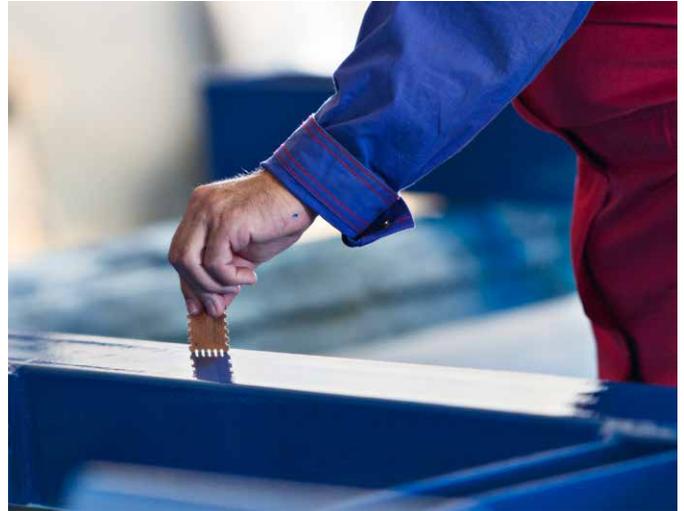
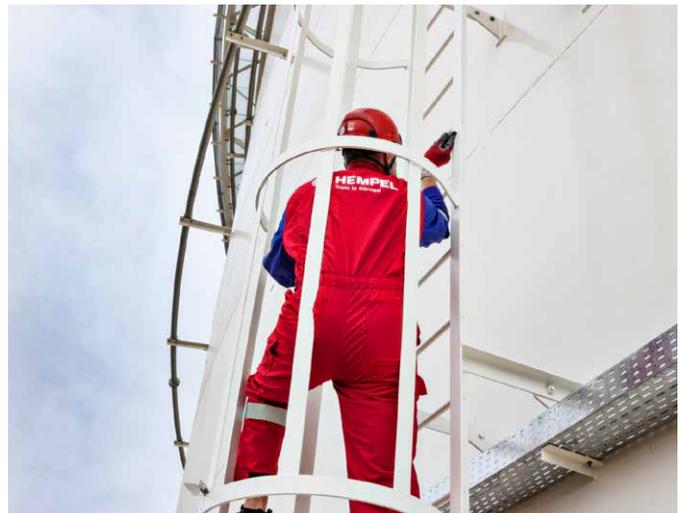
A thorough inspection of the facility revealed duct surface temperatures of up to 100°C with temperature fluctuations of up to 30°C. These temperature fluctuations on the ducts make regular coating intervals extremely challenging and require a continuous application without intervals. In addition, there were strong magnetic fields. This meant it was not possible to apply the magnetic- inductive measuring principle, making it challenging to determine dry film thicknesses, or any other electronical measuring tools. By using Hempel's Condition Survey and despite the challenging conditions, Hempel's coating advisors found a solution to assess the plant and subsequent how to repair the ducts without shutting down the plant.

An analysis of the survey data by Hempel's coating advisors uncovered the main problem: The existing coating system was chalking, which in turn resulted in corrosion of the ducts.

Regarding surface preparation, the team decided to only blast ducts with well-advanced corrosion; the ducts with heavy chalking but minor corrosion could be cleaned.

To meet the challenging temperature requirements, we specified a multi-layer coating system to ensure correct application under these circumstances.

Before application, we tested the unique system and repair procedure in our R&D laboratory and on site. Then, using insights from the Condition Survey, we created a customised application schedule with adjusted overcoating intervals for areas with particularly high surface temperatures and temperature fluctuations.
