# VATTENFALL + 30 years service life in the most aggressive environment with our solvent free epoxies technologies.

Horns Rev 1 was the first offshore wind farm in the North Sea, introducing solvent-free epoxies technologies that later become industry standard. Hempel painted different transition pieces.

PROJECT NAME  
Horns Rev 1

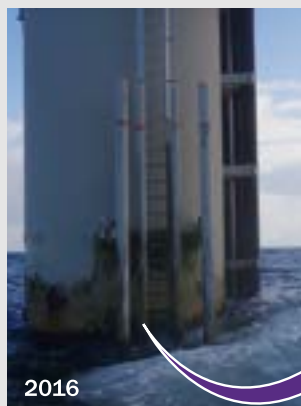
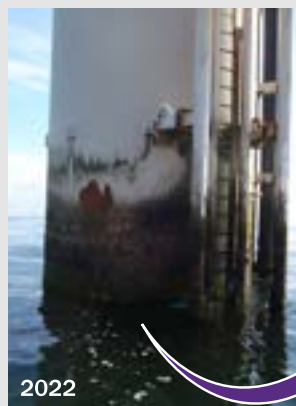
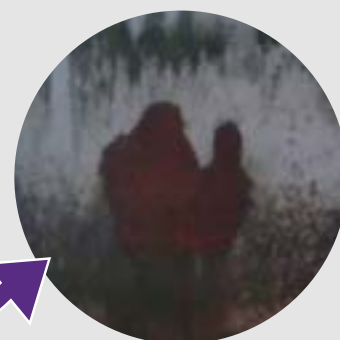
An area of mechanical damage was recorded on one of the transition pieces in 2016 and this was revisited in 2022:

“Comparison of extent of damage – 2016 and 2022. Except the already loosened coating in 2016 marked by the arrow, only relatively insignificant extent of under rusting and loss of coating along the edges of the damage have occurred over a period of 6 years in the splash zone”.
