# Hempatop Direct 700 Stamåsen Wind Park

In 2021 the wind park was visited to conduct an inspection in order to evaluate the **performance after 9 years in service**. The performance is of special importance since the present **Hempatop Direct 700** is the upgraded version of Hemparea DTM 55973.

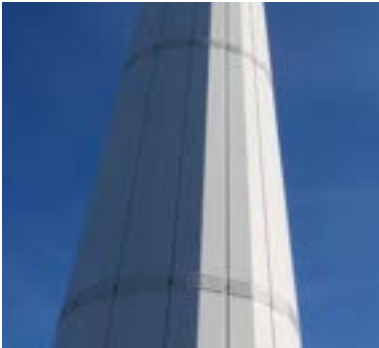
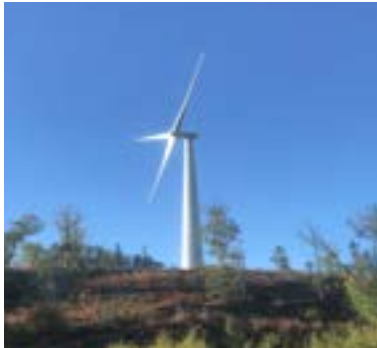
The inspected towers in Stamåsen Wind Park are in **excellent condition**. There can be found **no areas with breakdown and no indications of beginning breakdown** in the coating system on any of the eight towers (30 per cent of the turbine towers at Stamåsen) in the survey.

The stability of the coating system, being paint directly on blasted steel, paint on metallising or paint on the conversion pre-treated nuts is also well proven at the limited areas of mechanical damage. There is no spread of damage, **no corrosion creep and extremely limited red or white rust**.

The DFT show a paint system that is **very robust toward big variations in thickness**. The low thickness areas prove is an efficient barrier against water and corrosion. The high thickness areas are proof of a system that is very robust against the overapplication that often occur in industrial applications.

The gloss level has as expected dropped, a bit more facing south than facing north. There is **no tendency of chalking**.
