HEMPAGUARD® promises an absolute minimum of fouling over an entire docking period.

Excellent performance over five years

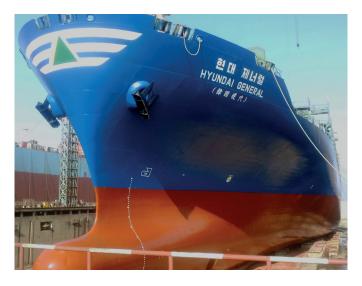
In January 2014, HYUNDAI GENERAL docked again. The silicone system applied five years earlier and the repair coating two years later had performed superbly. After high pressure fresh water washing at the Chengxi Shipyard (CSSC) in China, the coating looked glossy, fine, shiny and almost brand new.

During this docking the areas damaged by mooring and anchors were repaired using the HEMPASIL NEXUS X-TEND repair tie-coat. This time, however, the entire underwater area was coated with HEMPAGUARD X7 Fouling Defence, Hempel's latest development in silicone coatings.
